MCAS Miramar

HVAC Restoration and Optimization Project Building 7515

MCAS Miramar Phase 2: Cooling Tower Restoration

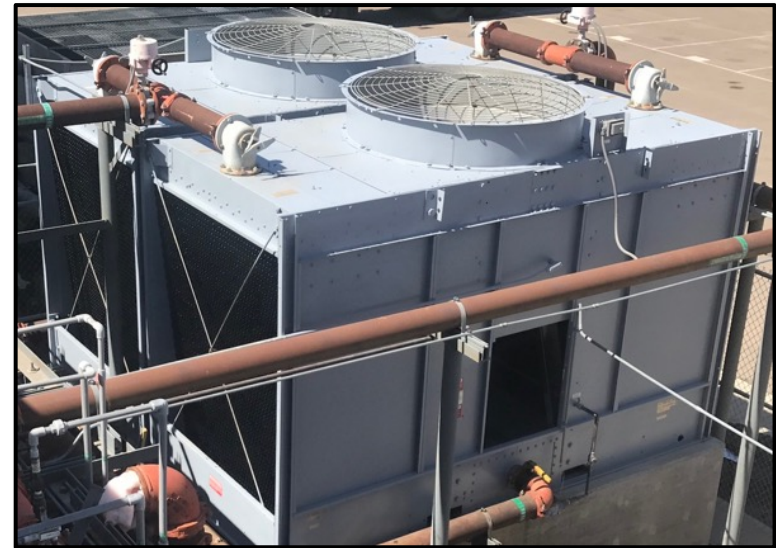
- *Arrests and prevents corrosion*
- *Provides protective coating of metal, keeping out of contact with water*
- *Extends useful life of tower*
- *Prevents excessive calcium and other build up on surfaces exposed to treated water*
- *Reduces maintenance costs*
- *Increases efficiency of system*
- *~40% of the cost to replace, releasing capital money for other facility needs*

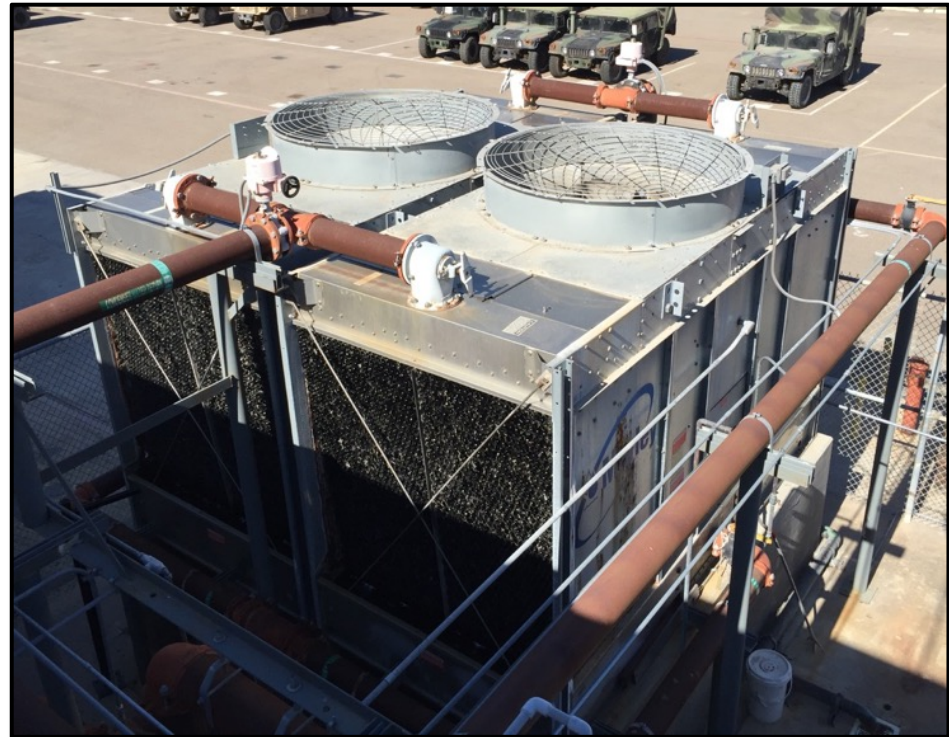
- **Protecall contracted to restore aging and failing cooling towers**
- **Cost of replacement was out of budget reach**
- **Towers were unable to perform at designed efficiency due to condition**
- **Corrosion was worsening resulting in additional leaks**

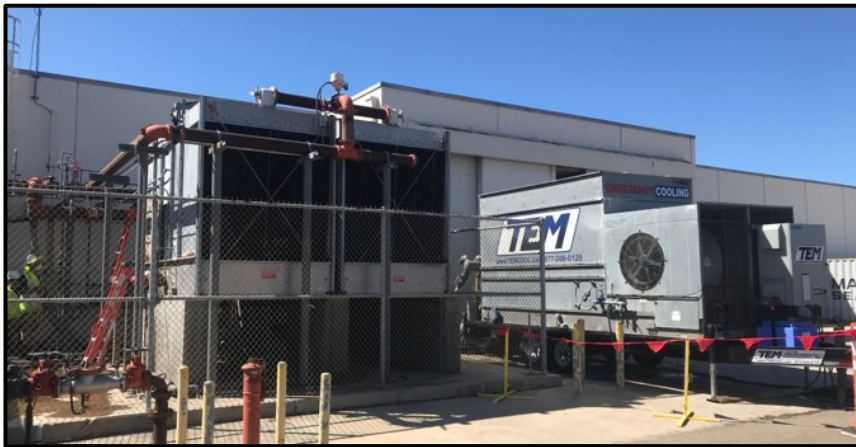
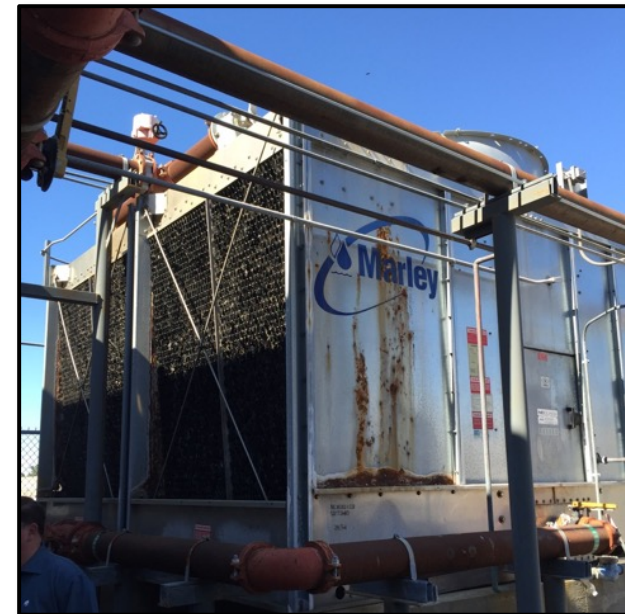
- Due to condition, a temporary rental system was brought in during restoration
- Initial preparation included removal of fill media
- Basin and all surfaces were thoroughly cleaned

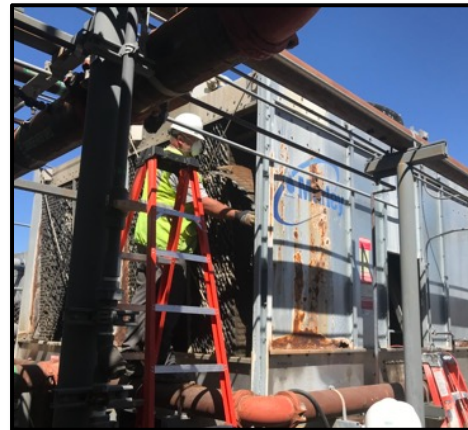
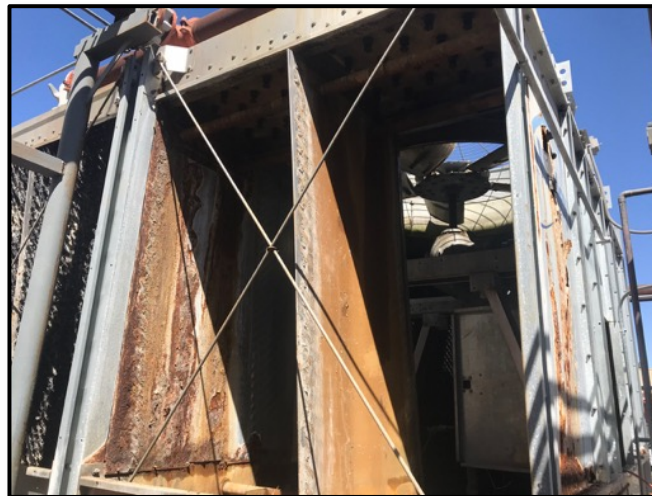
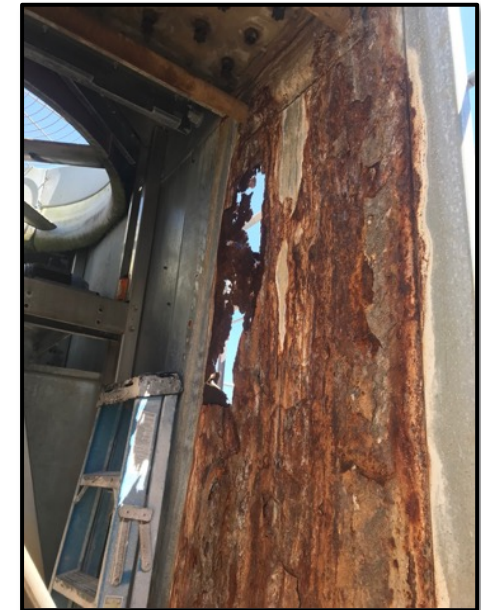
- **Accessible corroded panels were removed**
- **All areas showing signs of corrosion protected with Rust Grip**

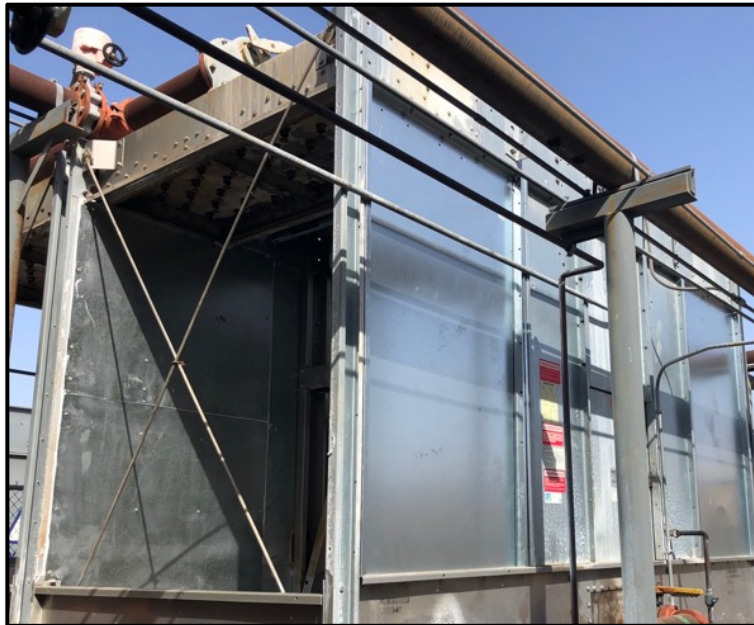
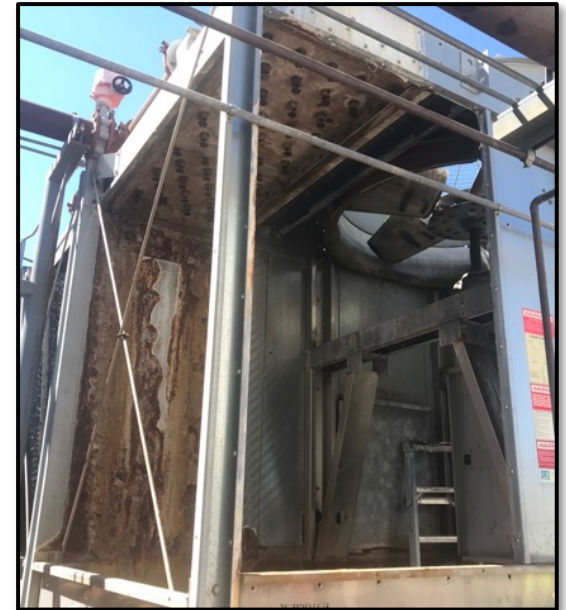
- **Major repairs of the metal structure were performed where extensive corrosion had deteriorated galvanized sidewalls**

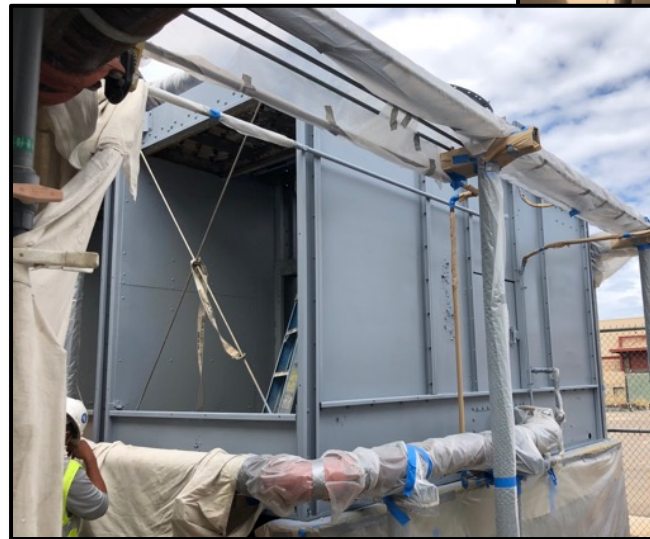
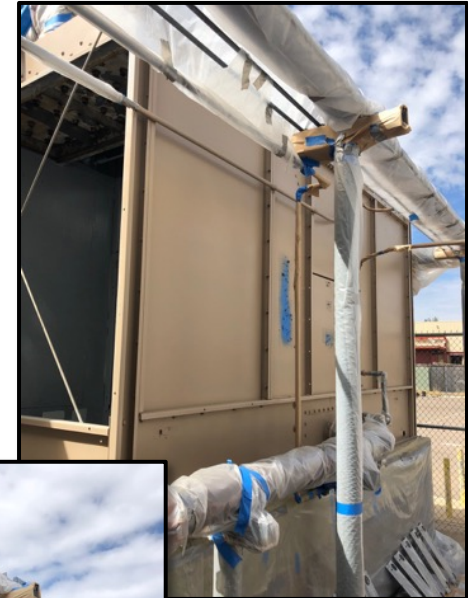
- Exterior surfaces were cleaned and prepared
- Surrounding areas were contained from overspray
- All exterior surfaces were primed to provide exceptionally strong adhesion
- Top coat was spray applied to provide corrosion resistant finish

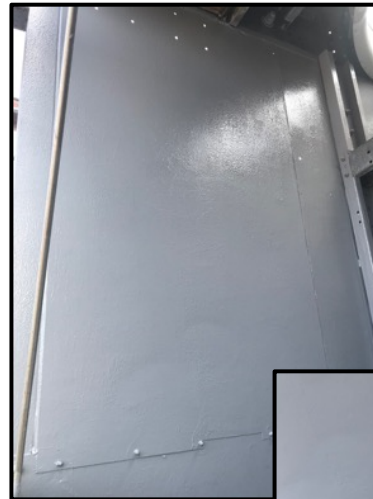
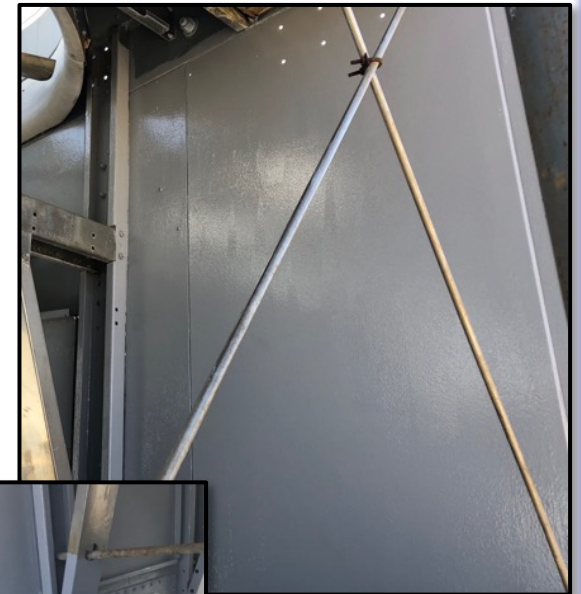
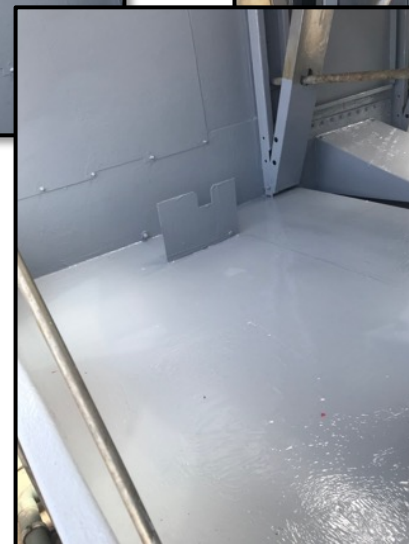
- **100% solids epoxy coating applied to provide superior protection and elimination of future corrosion or leaks**
- **Monolithic coating has flexibility to avoid cracks due to shock and vibration**
- **Coating provides strong, smooth cleanable surface for efficient performance of tower**

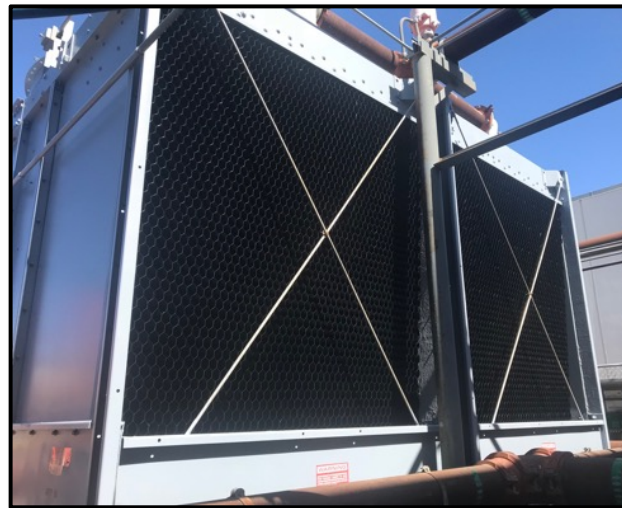
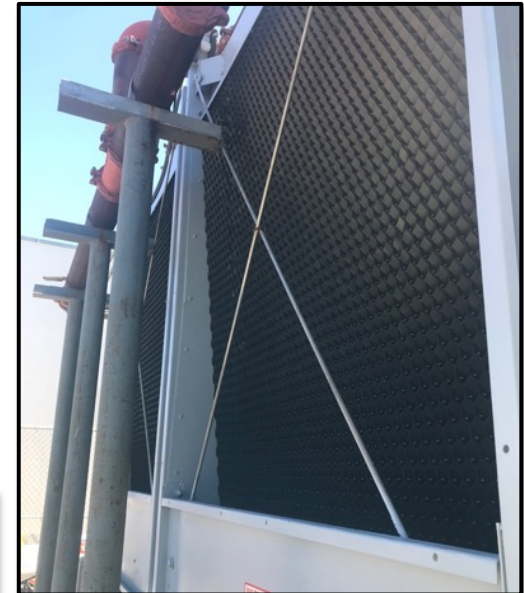
- **Full restoration included installation of new OEM fill media to extend useful life**
- **Hot deck restoration option can include same coating system and replacement of spiral nozzles**

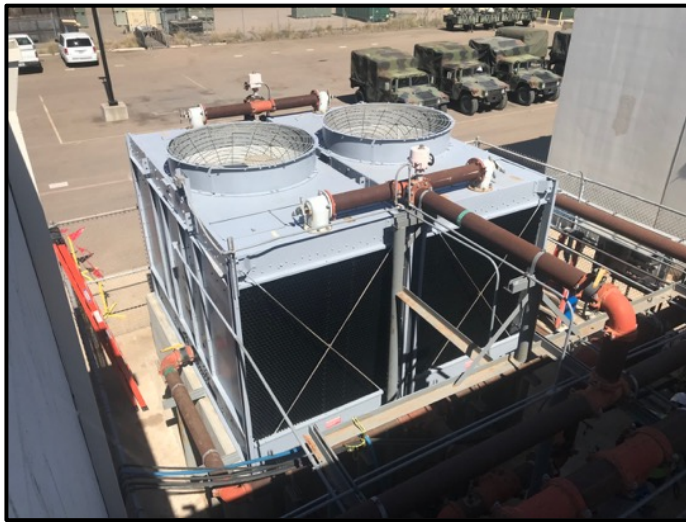
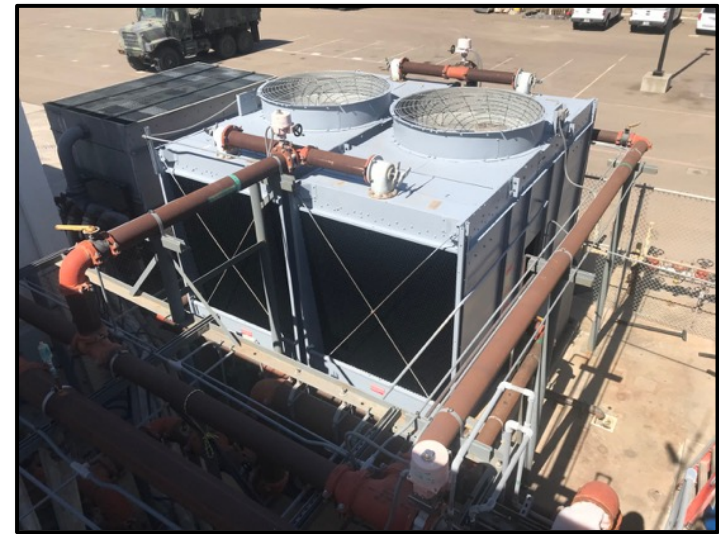
- **Fully restored cooling towers turned back over to base for full system operation**
- **Towers expected to have an additional 10 years or more of useful life**
